# PRESERVATION OF TOMBS OF SULTAN IBRAHIM & AMIR SULTAN MUHAMMAD, WHS MAKLI

**1<sup>ST</sup> CONSULTATIVE COMMITTEE MEETING**

***Folio IX – Geo-Technical &  
Structural Consultants' Assessments***

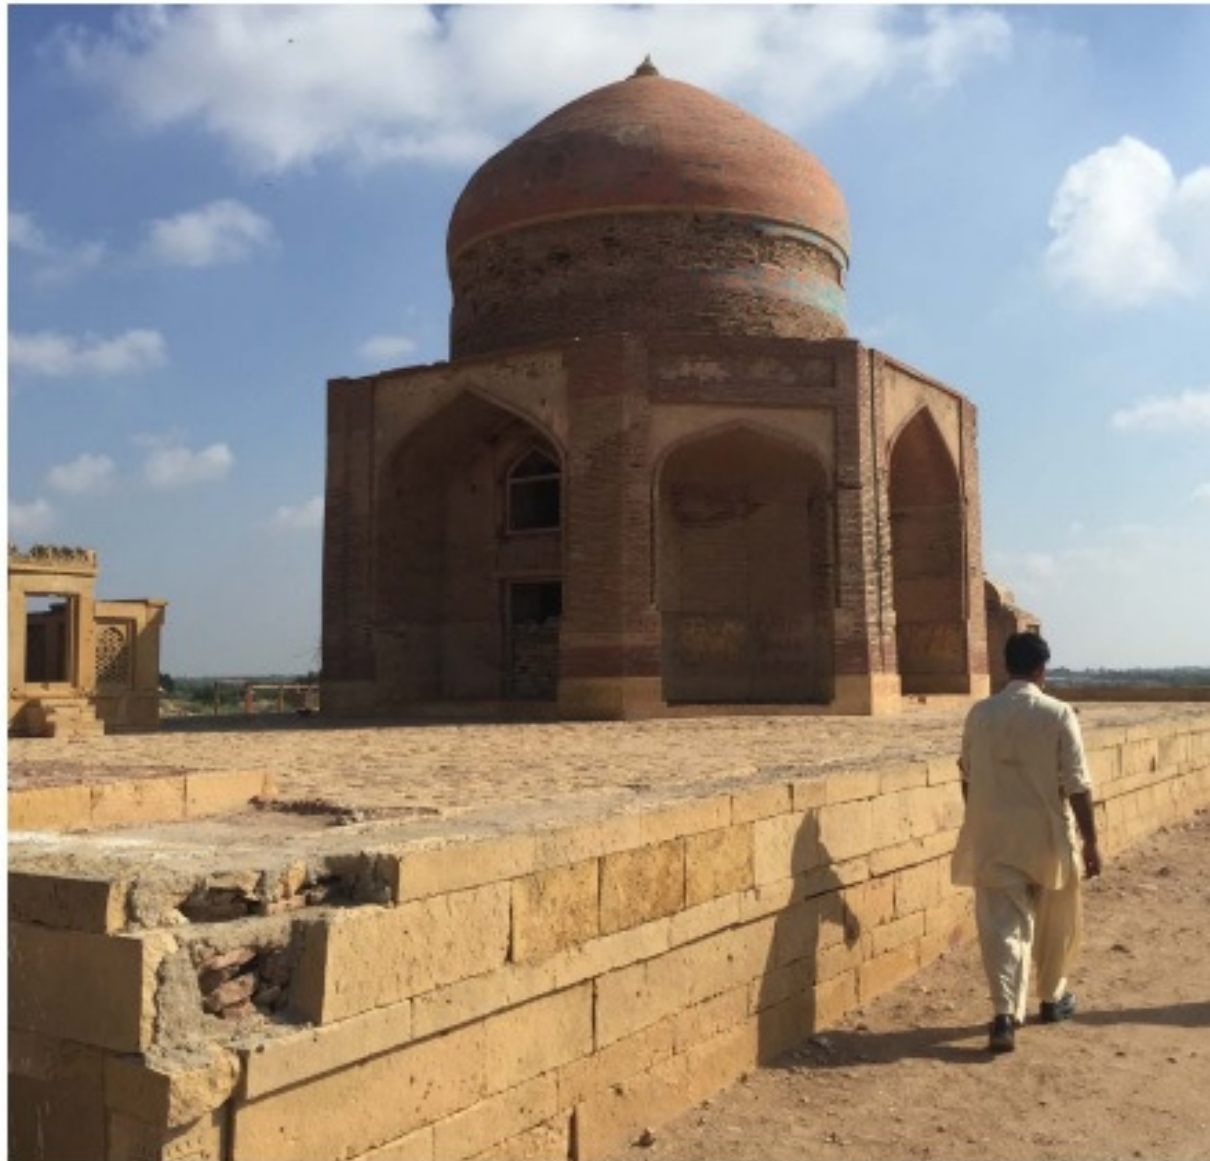
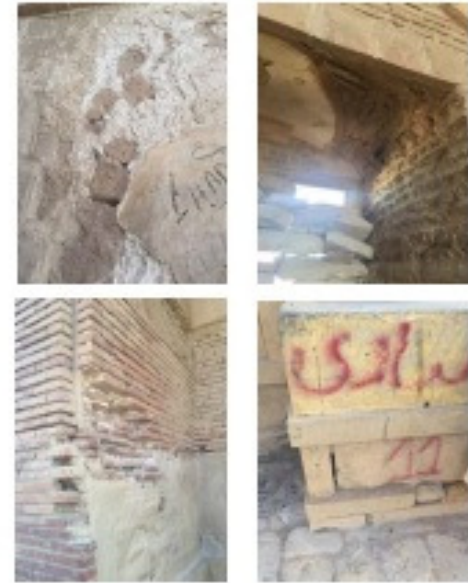
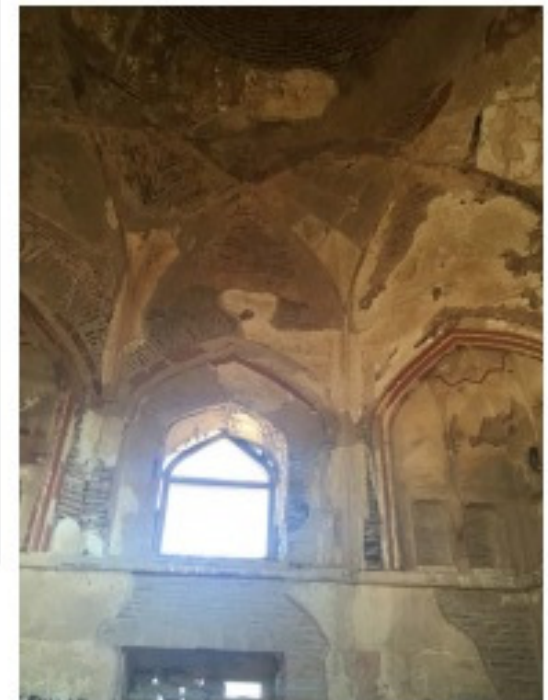
Structural Issues in Historic Masonry

**These structures were subject to severe floods and earthquakes during their life time so far and the signs of distress are quite visible from the surroundings. During floods these small hills were used as shelters hence much of the damages might be due to robbery or theft.**

**The apparent condition of Tomb of Sultan Ibrahim does not immediately alarm about global instability cause there is no significant tilt, major diagonal or vertical cracks at present.**

**These cracks if existed might have been repaired but never reappeared till now. Local spalling and detachments are quite expected.**

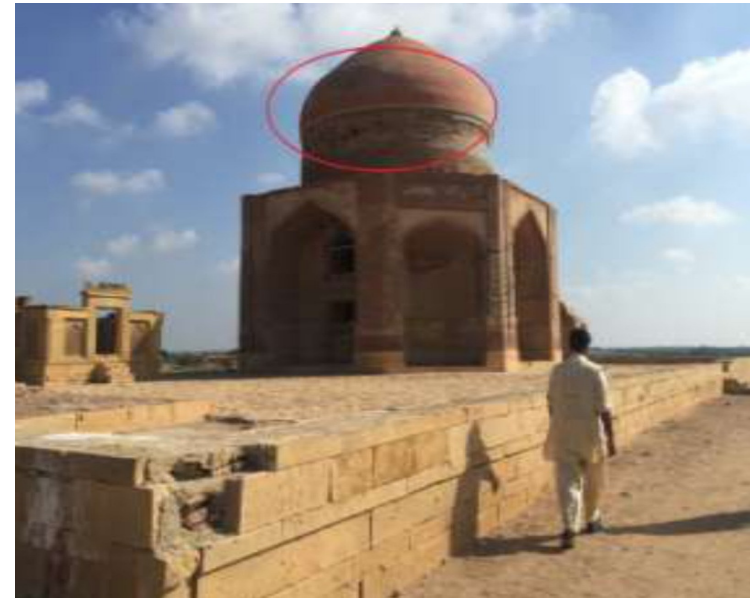
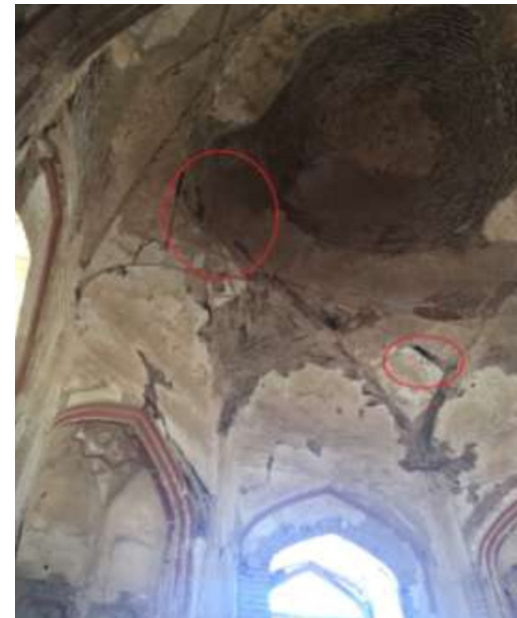
## OBSERVATIONS ON DOME

**The dome itself has outer main shell and inner as false shell. Outer dome shell has few dents distorting the round geometry and look critical.**

**The inner dome has very damaged condition with lots of spalling , pitting or detachments may be sort of crumblings or just the damage by birds keen to making holes or nests.**

**This part is serious and need to be supported by some sound arrangement or immediate conservational strengthening.**

- **The Tomb of Sultan Ibrahim and Amir Sultan Muhammad comes under Zone C except dome which comes under zone D.**
- **The dome looks critical and need to be supported immediately; therefore the temporary scaffolding system is recommended.**
- **Moreover, bamboo cover may protect the grave with wooden planks as base.**
- **Tomb has not suffered any distress related to the performance of foundation system as per geo-technical report**
- **As per geo-technical report, around the Tomb, platform of stone blocks covers the surrounding sub-grade and saved it from weathering. But the lime mortar binding the stone blocks has weathered over the period which provides access to the rain water to percolate into the sub grade. So, the lime mortar binding should be renewed as it could be harmful to the structure causing weathering of sub grade and weakening of foundation system supporting the Tomb.**
