PRESERVATION OF TOMB OF JAN BABA, WHS MAKLI

1ST EXPERTS' COMMITTEE MEETING

Folio XI – Consultants' Assessments

STRUCTURAL ASSESSMENT

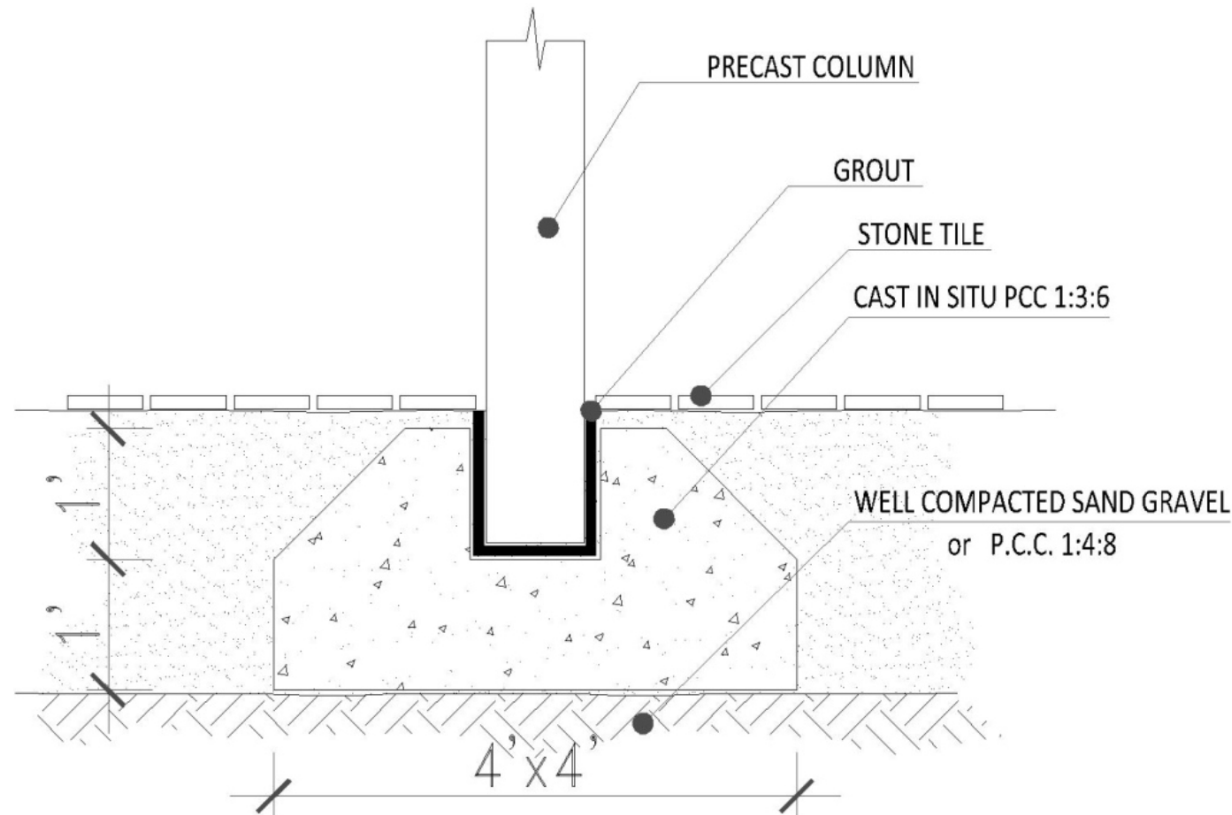
TYPICAL DETAIL FOR PRECAST FOUNDATION SECTION

TILTS IN COLUMNS

The foundation of columns with visible tilts are to be treated as per below sketch. The stone masonry of columns is to be reassembled in proper alignment. Similarly the side chambers are to be reassembled in correct alignment.

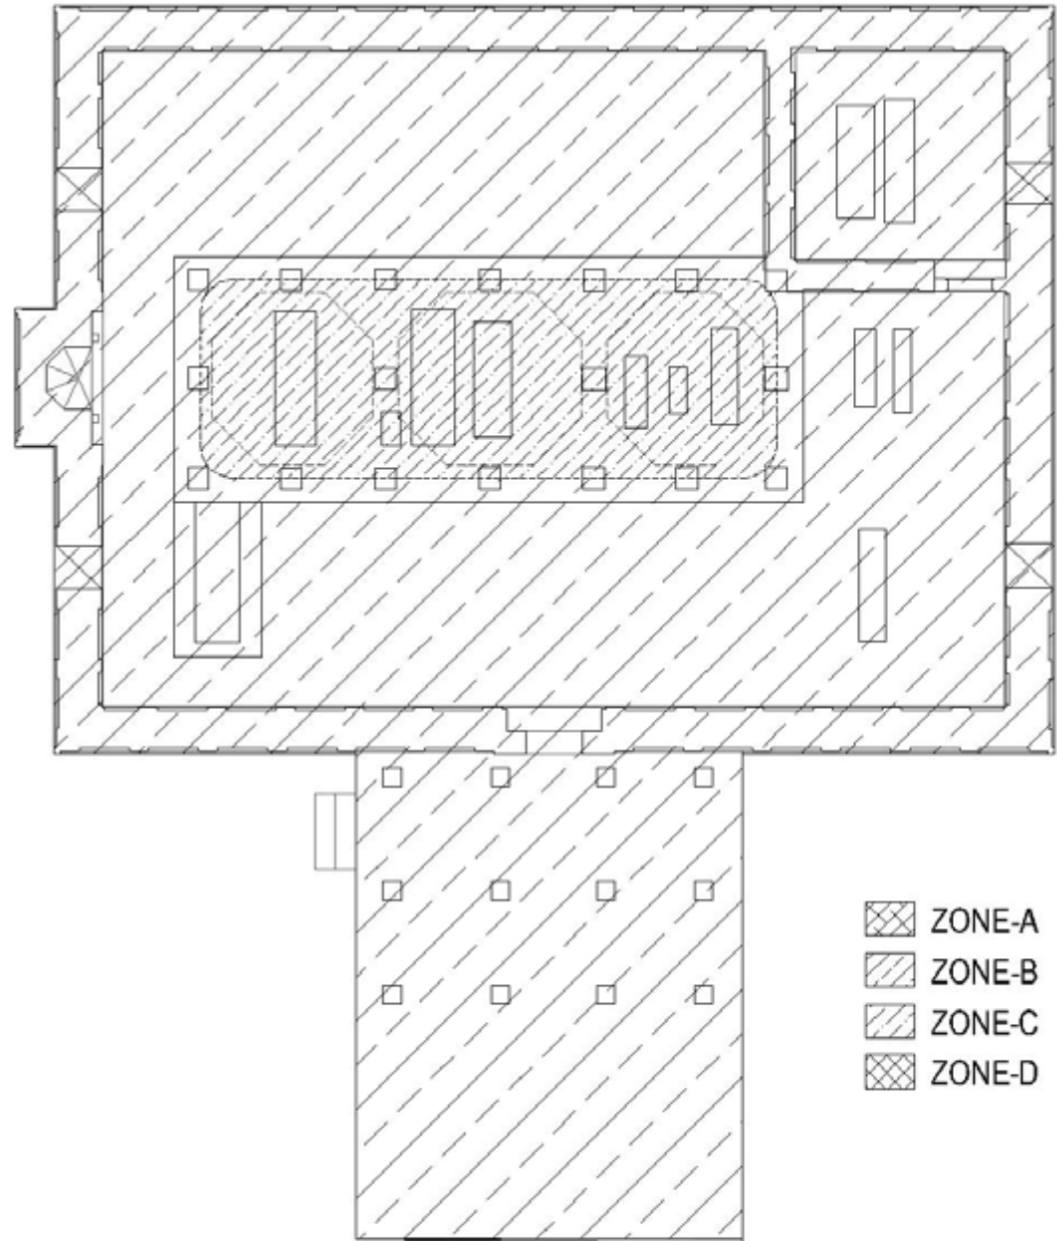
The Tomb of Jan Baba comes under Zone B except domes which come under zone C. The domes look critical and need to be supported immediately; as a temporary solution the opening needs to be covered. These domes to be reconstructed as per original fabric and materials as final solution.
