# RESTORATION OF HISTORIC CALCUTTA HOUSE NANAKWARA, KARACHI

HERITAGE FOUNDATION OF PAKISTAN

## RESTORATION REPORT MARCH 2018

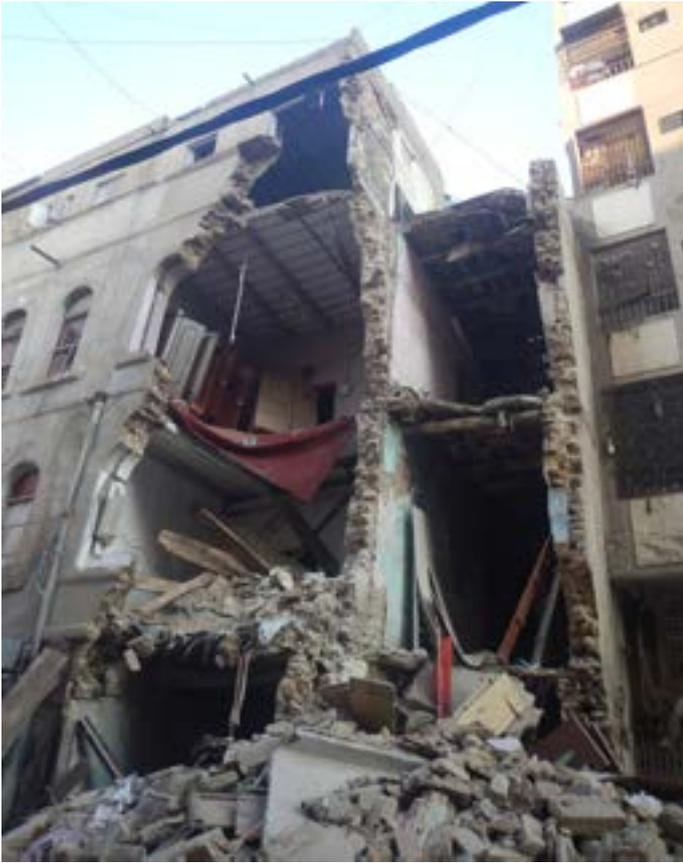
The collapse of the NW portion was caused due to unsuitable interventions and free seepage of water into the basic structure. The remaining masonry however, remains stable but suffers from loss of mortar and some cracks due to lack of maintenance. 18 families occupied small apartments on three levels while the ground floor is occupied by shops. The building has undergone renovations over the past several years. The central well was remodeled with poorly constructed reinforced concrete columns, beams and slabs, while on other floors the original slabs have been replaced with steel girders while the new top floor is constructed using g.i. sheets for roofing.

Collapsed North East Corner

- **As the original walls of the structure are stable, minor cracks and defects that are visible in the original walls can be easily rectified.**
- **The collapsed portion of the wall needs to be rebuilt with a combination of original and matching new stones.**
- **The later-period RCC columns and beams are dangerous and should be carefully dismantled after providing support to the internal balconies with steel girders.**
- **Later-period RCC balcony on south, third floor construction and other attachments to original walls, need to be dismantled.**
- **Majority of slabs on steel girders and steel T sections are generally in fair condition, but may require localized retrofitting.**

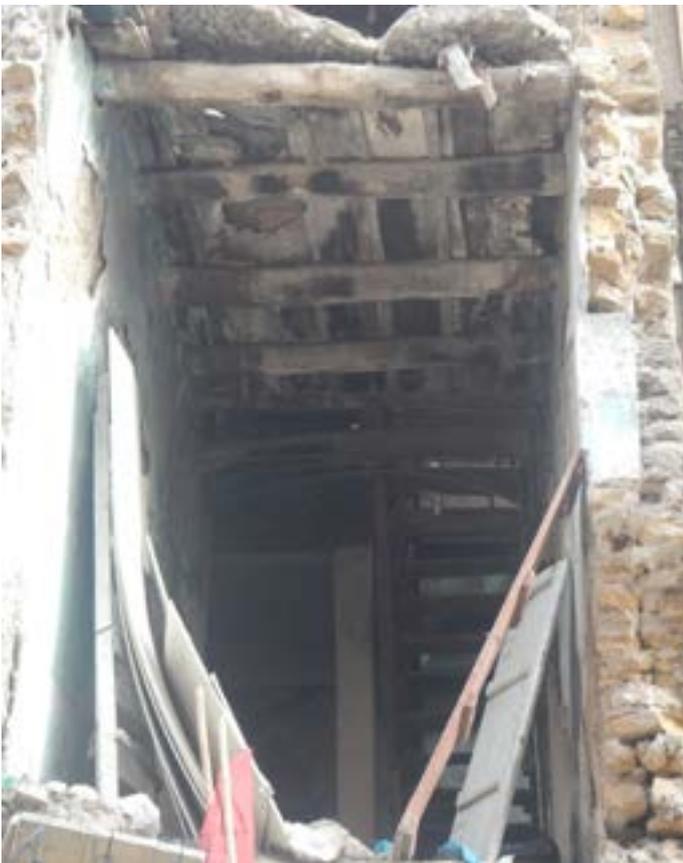
Collapsed Structure

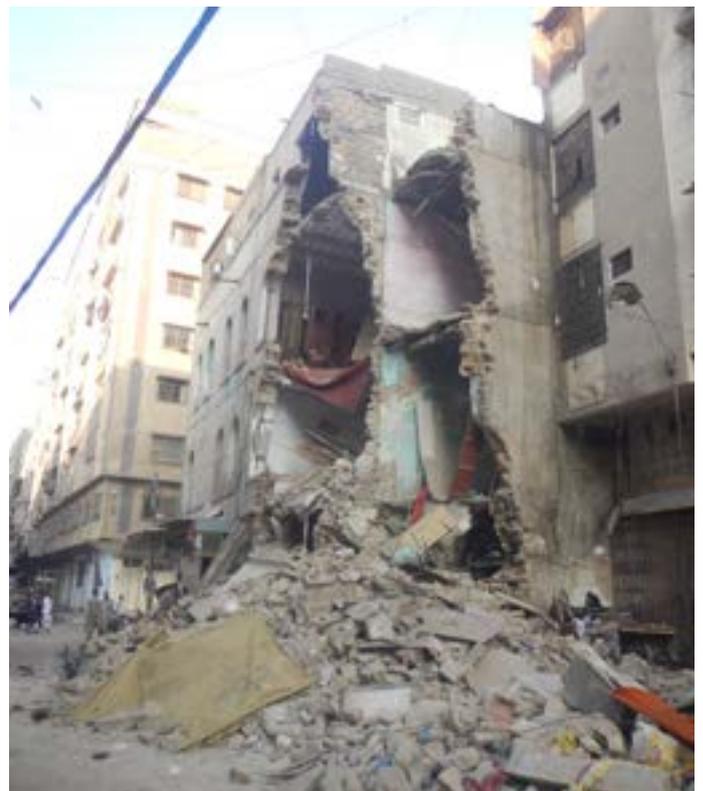
Collapsed Corner & Debris

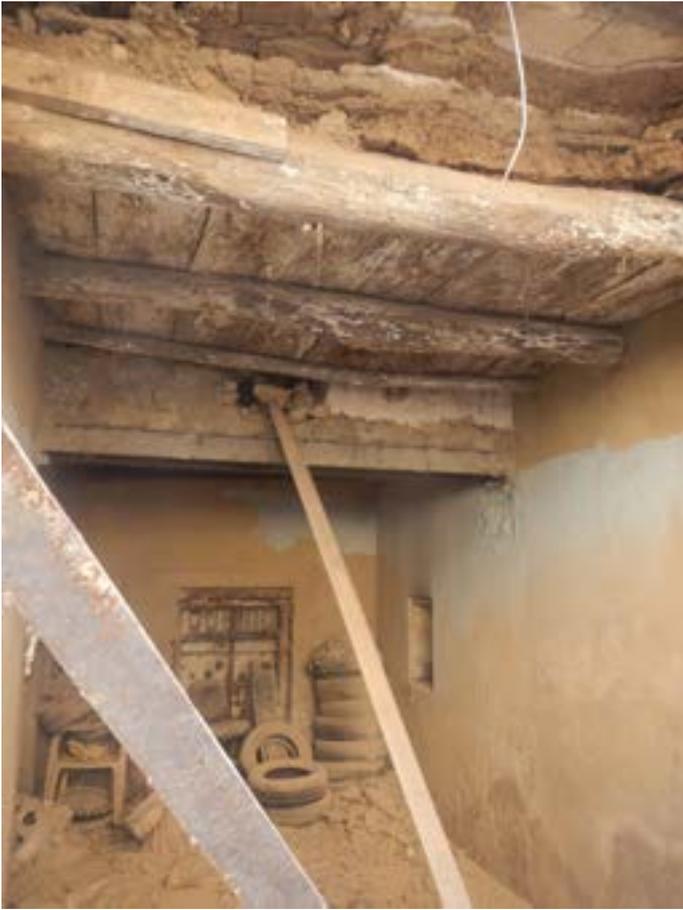
Interior of a collapsed shop

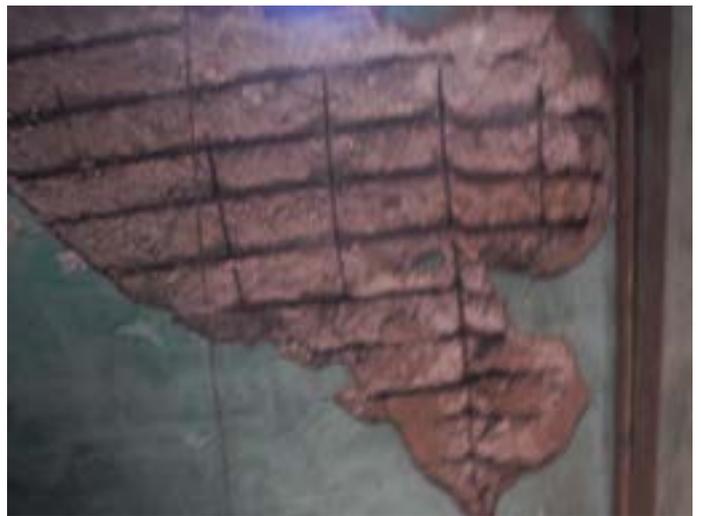
Damaged RCC First Floor Slab
