# US Ambassador's Fund for Cultural Preservation

## Tombs of Sultan Ibrahim & Amir Sultan Muhammad at WHS Makli, Thatta

### Progress Report No - 2015/004-1

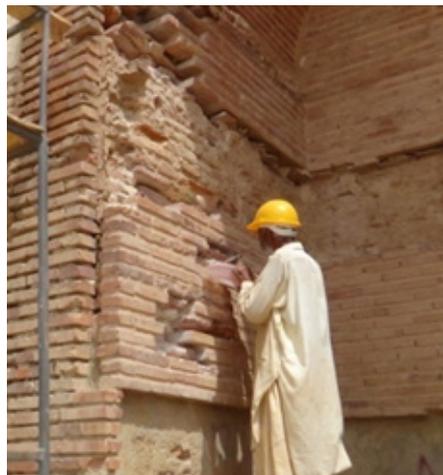
Area before underpinning treatment

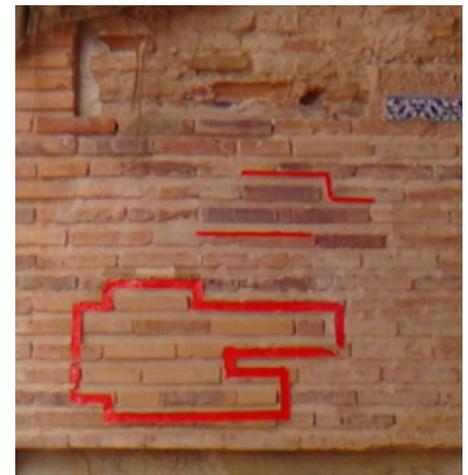
During the underpinning process

After the completion of underpinning

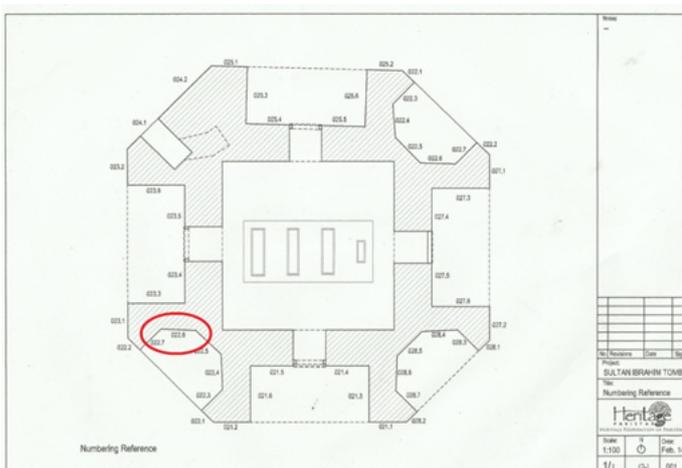
Drawing marking the Underpinning of faces 22.6 & 22.7

At the same time, marking on drawings of underpinning work is also being carried out. This is to maintain careful records of the work for any future assessment or review.

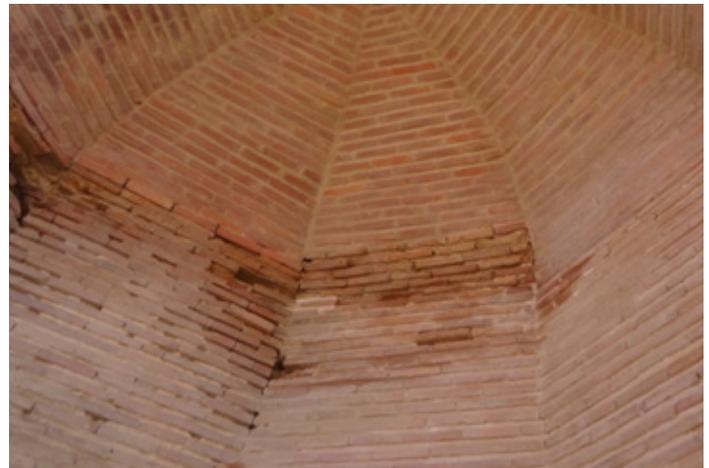
Underpinning of faces 22.6 & 22.7

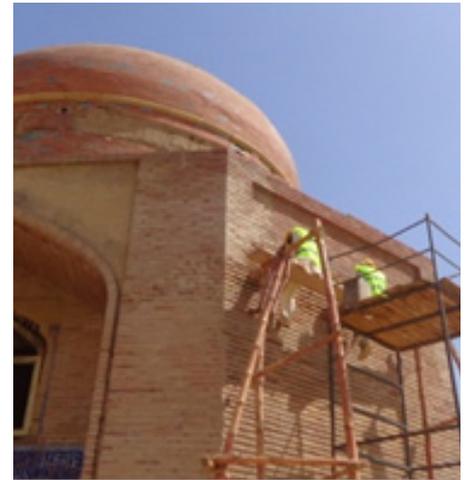
*Pointing of historic bricks*

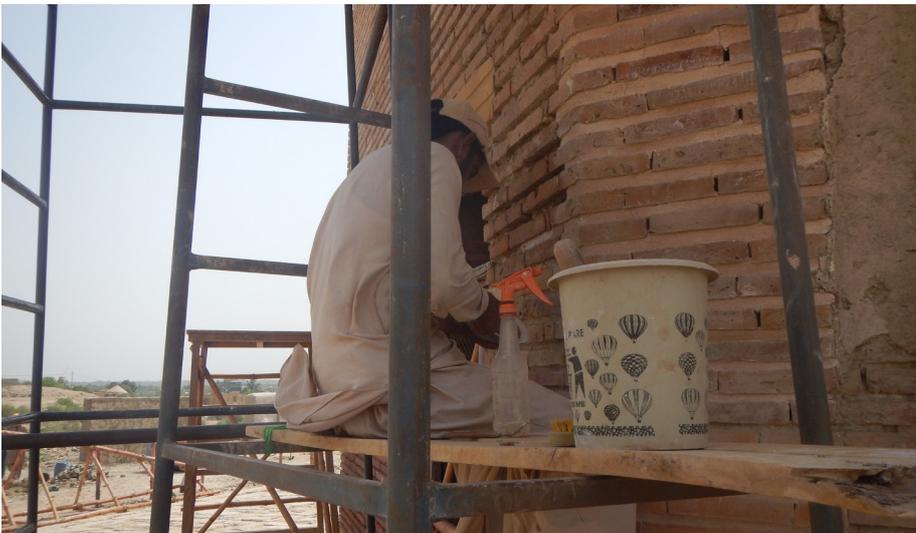
*Progress of pointing*

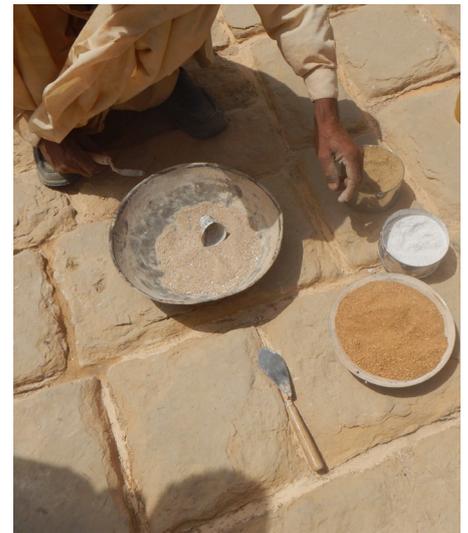
*Preparing the daily mix for pointing*

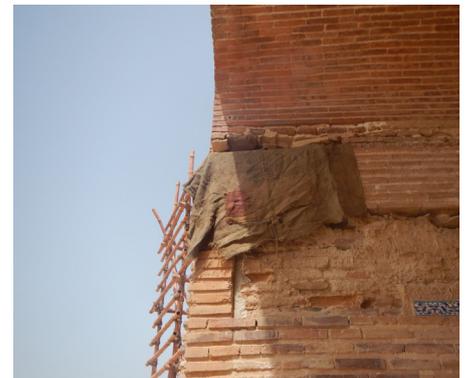
Due to the exposed condition of the monument and rising heat intensity, all possible care is being taken to ensure that curing of pointing as well as underpinning is carried out regularly. Gunny bags have been hung on areas where pointing is done and a person is dedicated to continue sprinkling water to keep the gunny bags damp and consequently dampness in lime pointing is maintained for seven days.

*Curing of mortar joints*

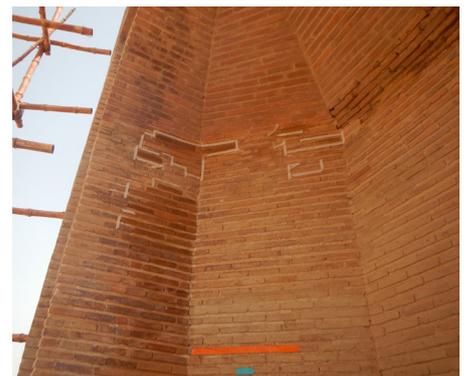
The work of underpinning is being delineated by marking the extents of new work with coloured tapes. This is being done in order that visitors could identify the new work.

*Areas treated by underpinning*

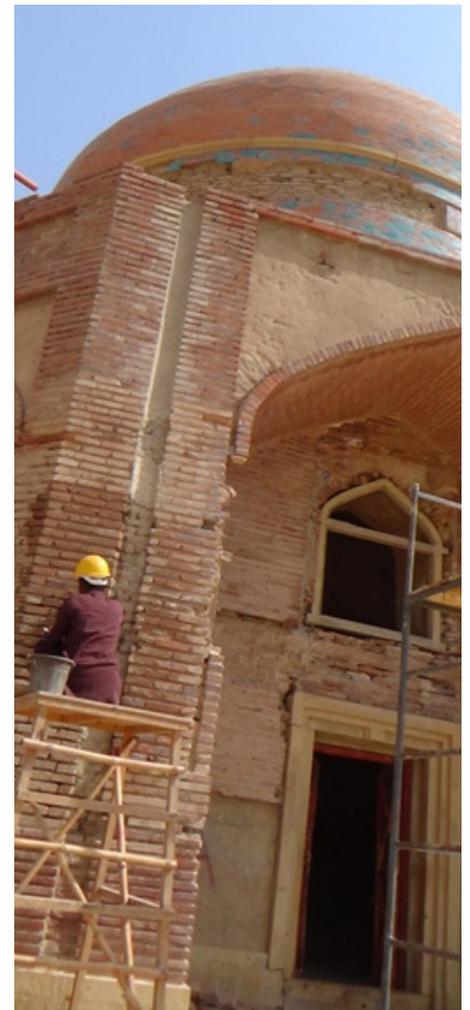
*Pointing of historic bricks*

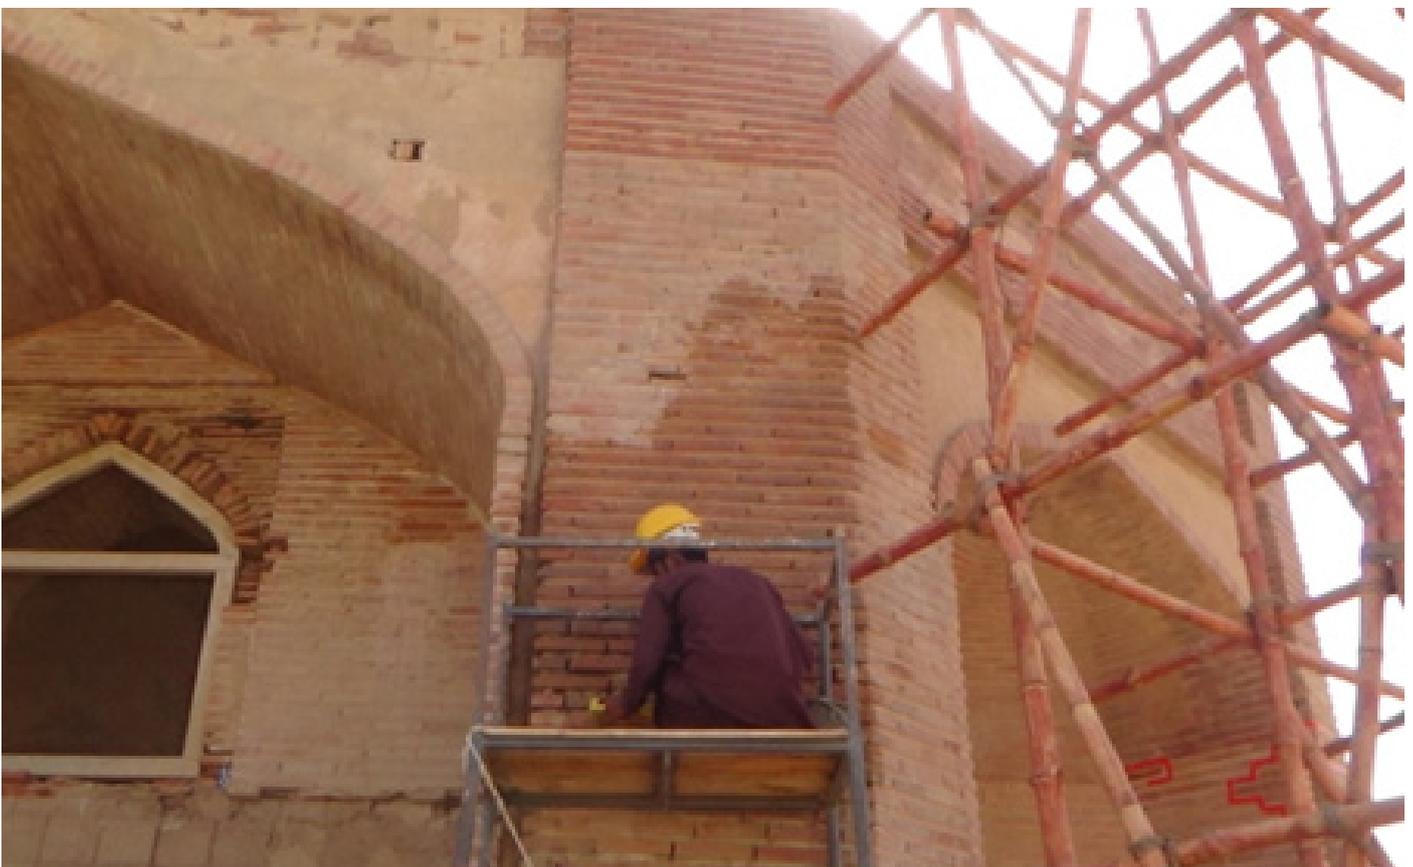
*Artisans treating the mortar joints by pointing*

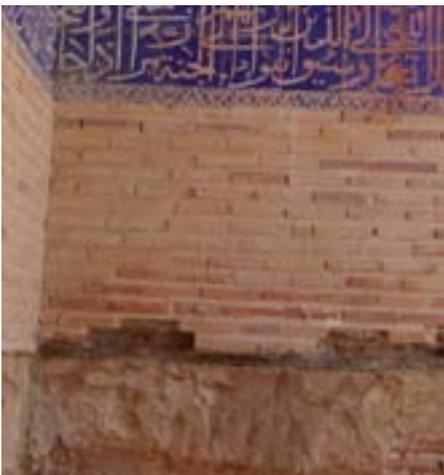
Area before underpinning treatment.

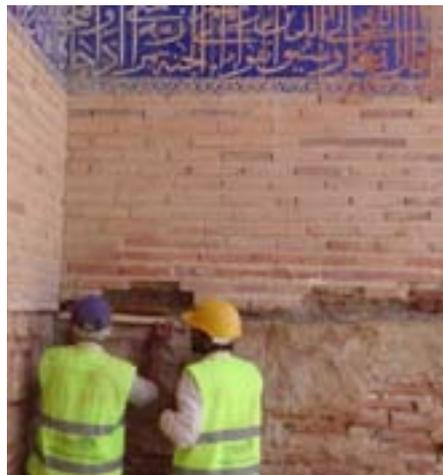
During the underpinning process.

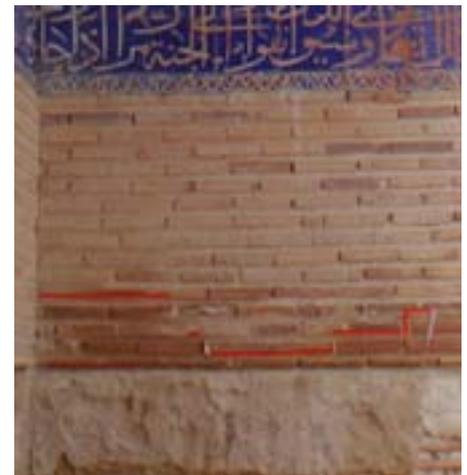
After the completion of underpinning.

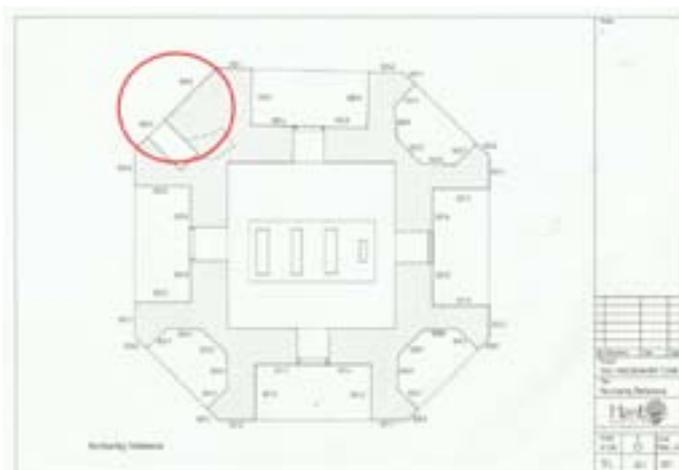
Drawing marking the Underpinning of faces 24.6 & 24.7.

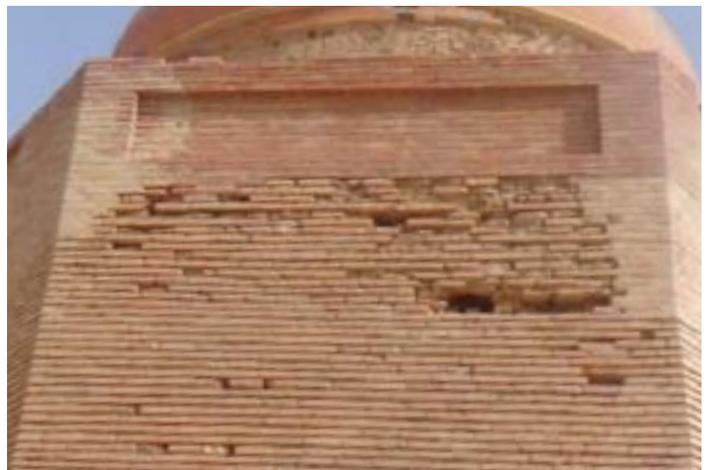
Underpinning of faces 24.6 & 24.7.

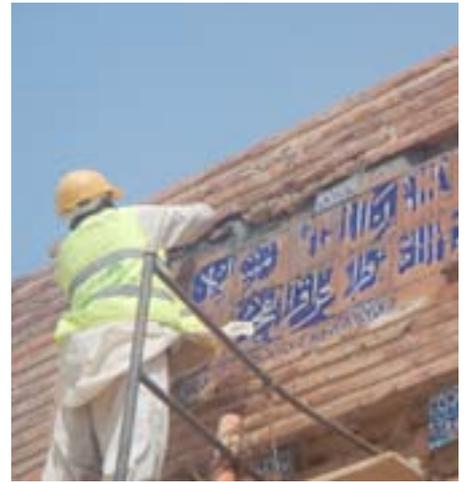
*Pointing of historic bricks around the Kashi.*

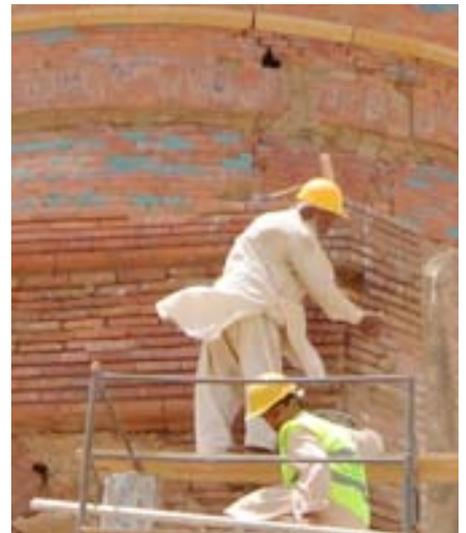
*Pointing of exterior surfaces.*

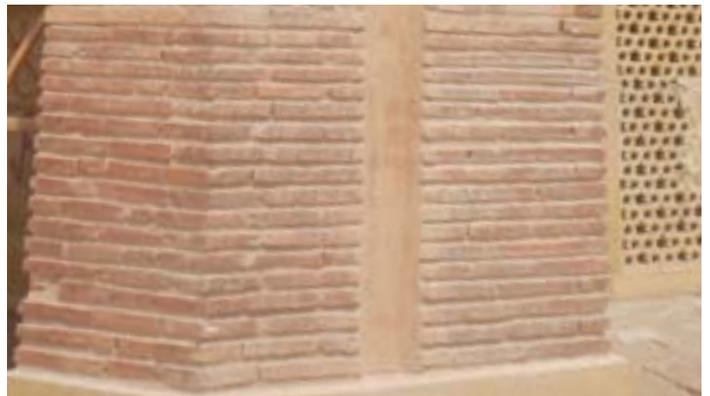
*Plaster of drains.*

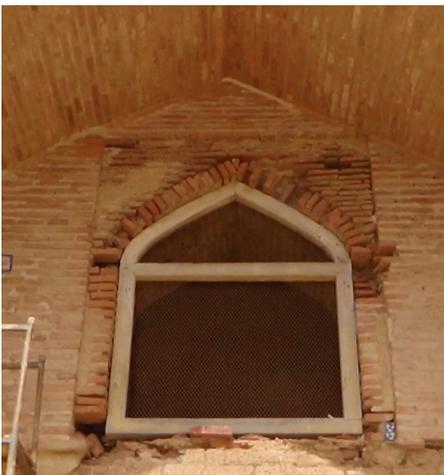
*Area before underpinning treatment.*

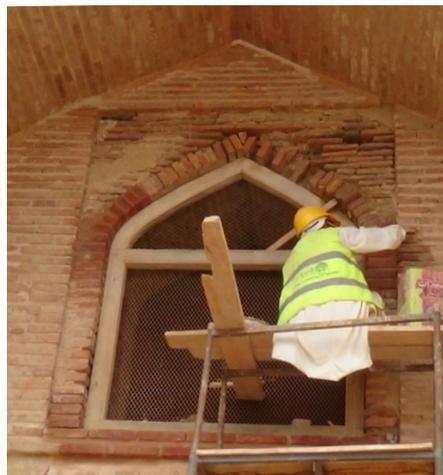
*During the underpinning process.*

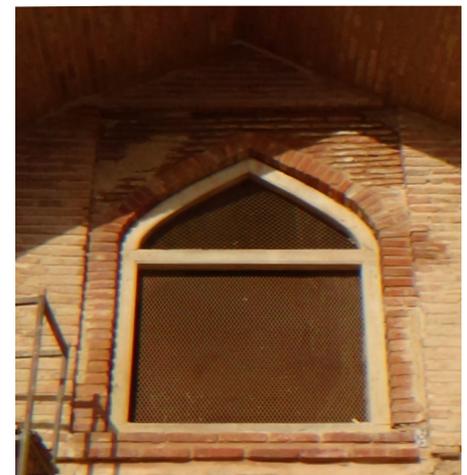
*After the completion of underpinning.*

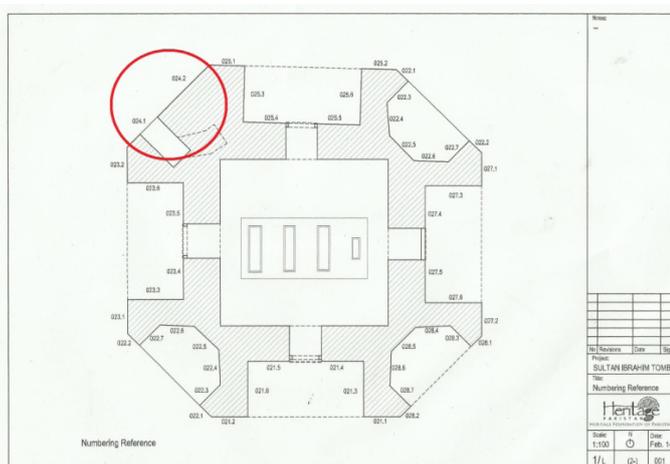
*Drawing marking the Underpinning of faces in the stairwell.*

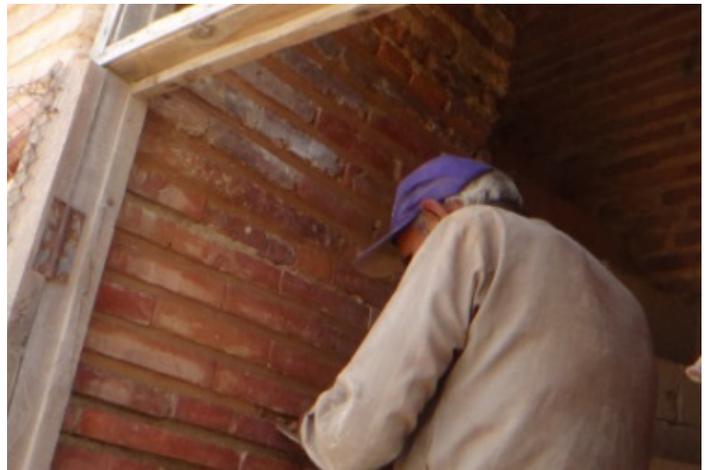
*Underpinning of faces in the stairwell.*

ing the conservation work of the dome. Hence during the last week of June, the North-South stretch of the scaffolding was completed. The important point to consider is that the scaffolding The work on the interior started from the underpinning and pointing of mortar joints of the staircase area, leading to the roof. This was followed by the pointing of the interior West, North and East alcoves.

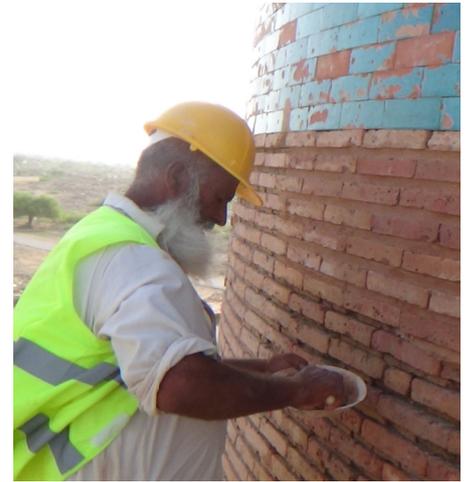
Pointing of historic bricks.

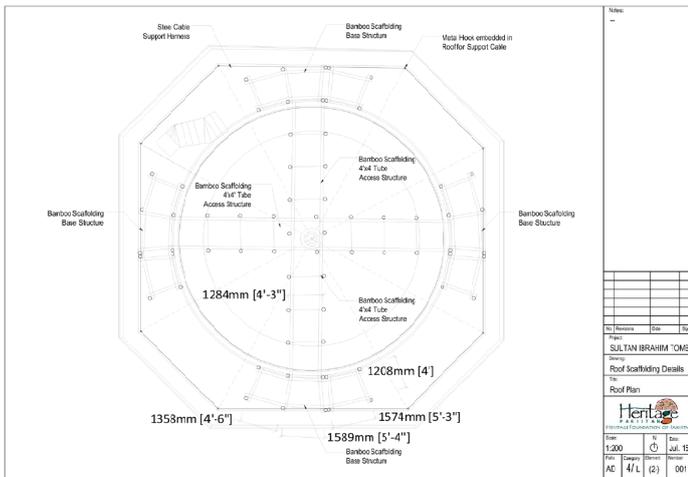
- The critically sensitive areas requiring underpinning, such as the periphery of Kashi tiles and areas around the window frames were completed. Underpinning of the window frames on the West & North sides was completed in the first week.
- Underpinning of the Drum from West, North and East sides was completed in the second week of June. The ratio used for mortar is 1:2:3 (pottery dust, sand, lime). Also the underpinning of the area near the Kashi tiles was completed in the same week.
- During the third week of June, the bamboo scaffolding for the dome began construction from the North side. The scaffolding will go 16'-0" vertically, and then taper to protect the top of the dome. The scaffolding is necessary to take every precaution while working on the Dome.
- The bamboo scaffolding is designed as a cross, to allow for maximum possible access and support dur-

Layout Plan for the Bamboo Scaffolding.

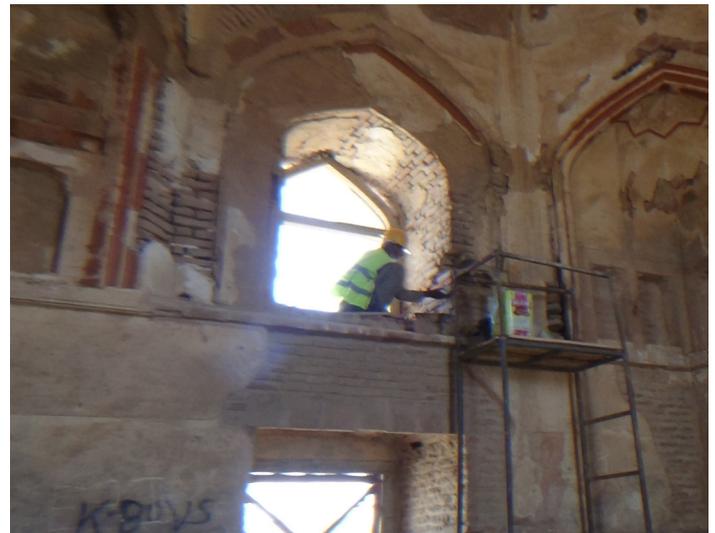
Pointing of the interior walls.

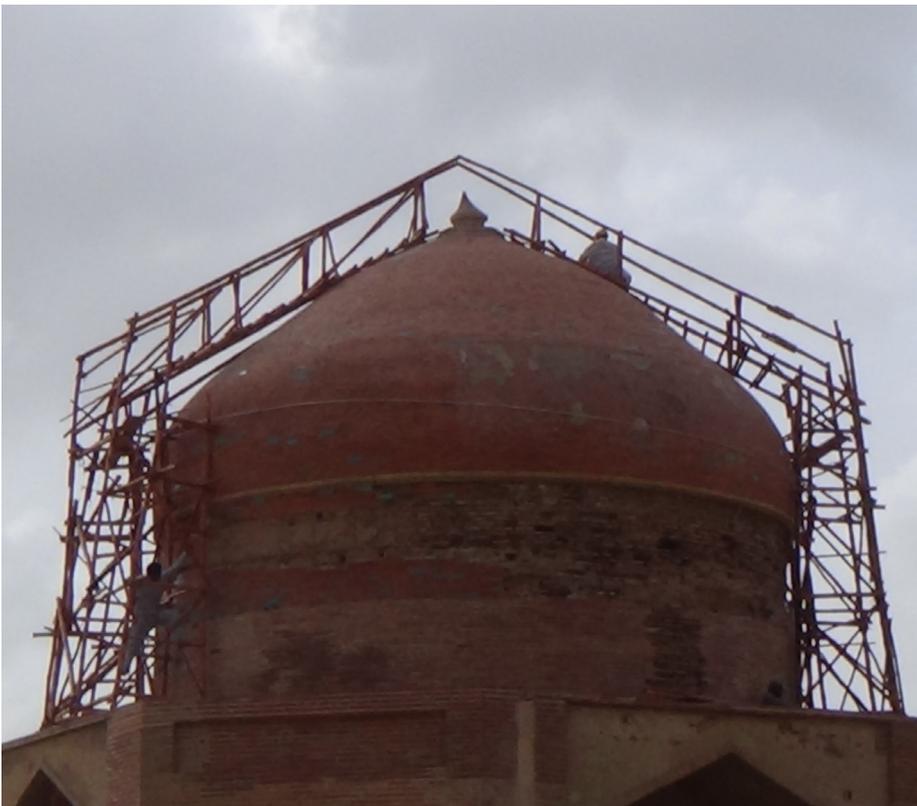
North-South Bamboo Scaffolding.

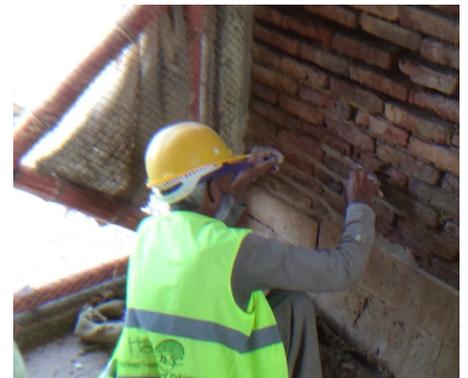
Pointing of mortar joints.

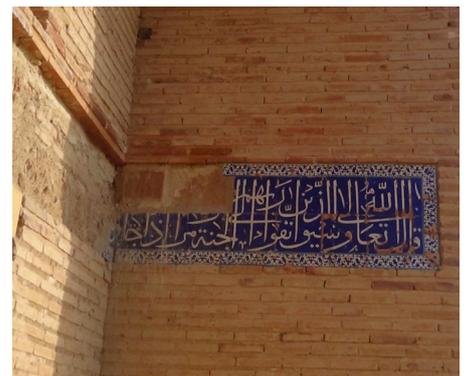
Areas treated by underpinning.
