**CONSERVATION RECORD DOCUMENT**  
Preventive Conservation / Conservation Works

**Samma Noble I & II, Makli**

Name of Work:  
Provision of Temporary Supports

**World Heritage Site at Makli, Thatta – WHS4  
Cluster 1, Samma Monuments**

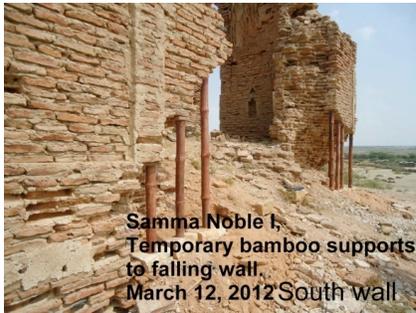
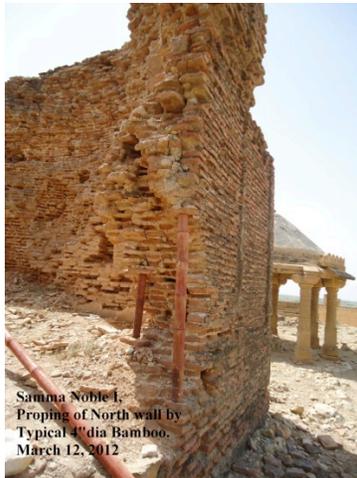
**1.9 Photographs Samma Noble I**

Placing of bamboo supports to all the leaning and or badly damaged brick walls in subject structures i.e. Tomb of Samma Noble I and II. The propping was carried out using about 4" diameter bamboo poles placed on lime stone base with about 4" diameter and 1 ½ " deep seat so that bamboos are not in direct contact with earth. Similarly, 4" x 6" and about an inch thick timber packing was placed between the top of the bamboo and the wall bricks. The locations were on all four sides of the Tomb of Samma Noble I and on South & West walls of Samma Noble 2 as seen in photographs below.
