# PRESERVATION OF TOMBS OF SULTAN IBRAHIM & AMIR SULTAN MUHAMMAD, WHS MAKLI

**1<sup>ST</sup> CONSULTATIVE COMMITTEE MEETING**

***Folio IX – Geo-Technical &  
Structural Consultants' Assessments***

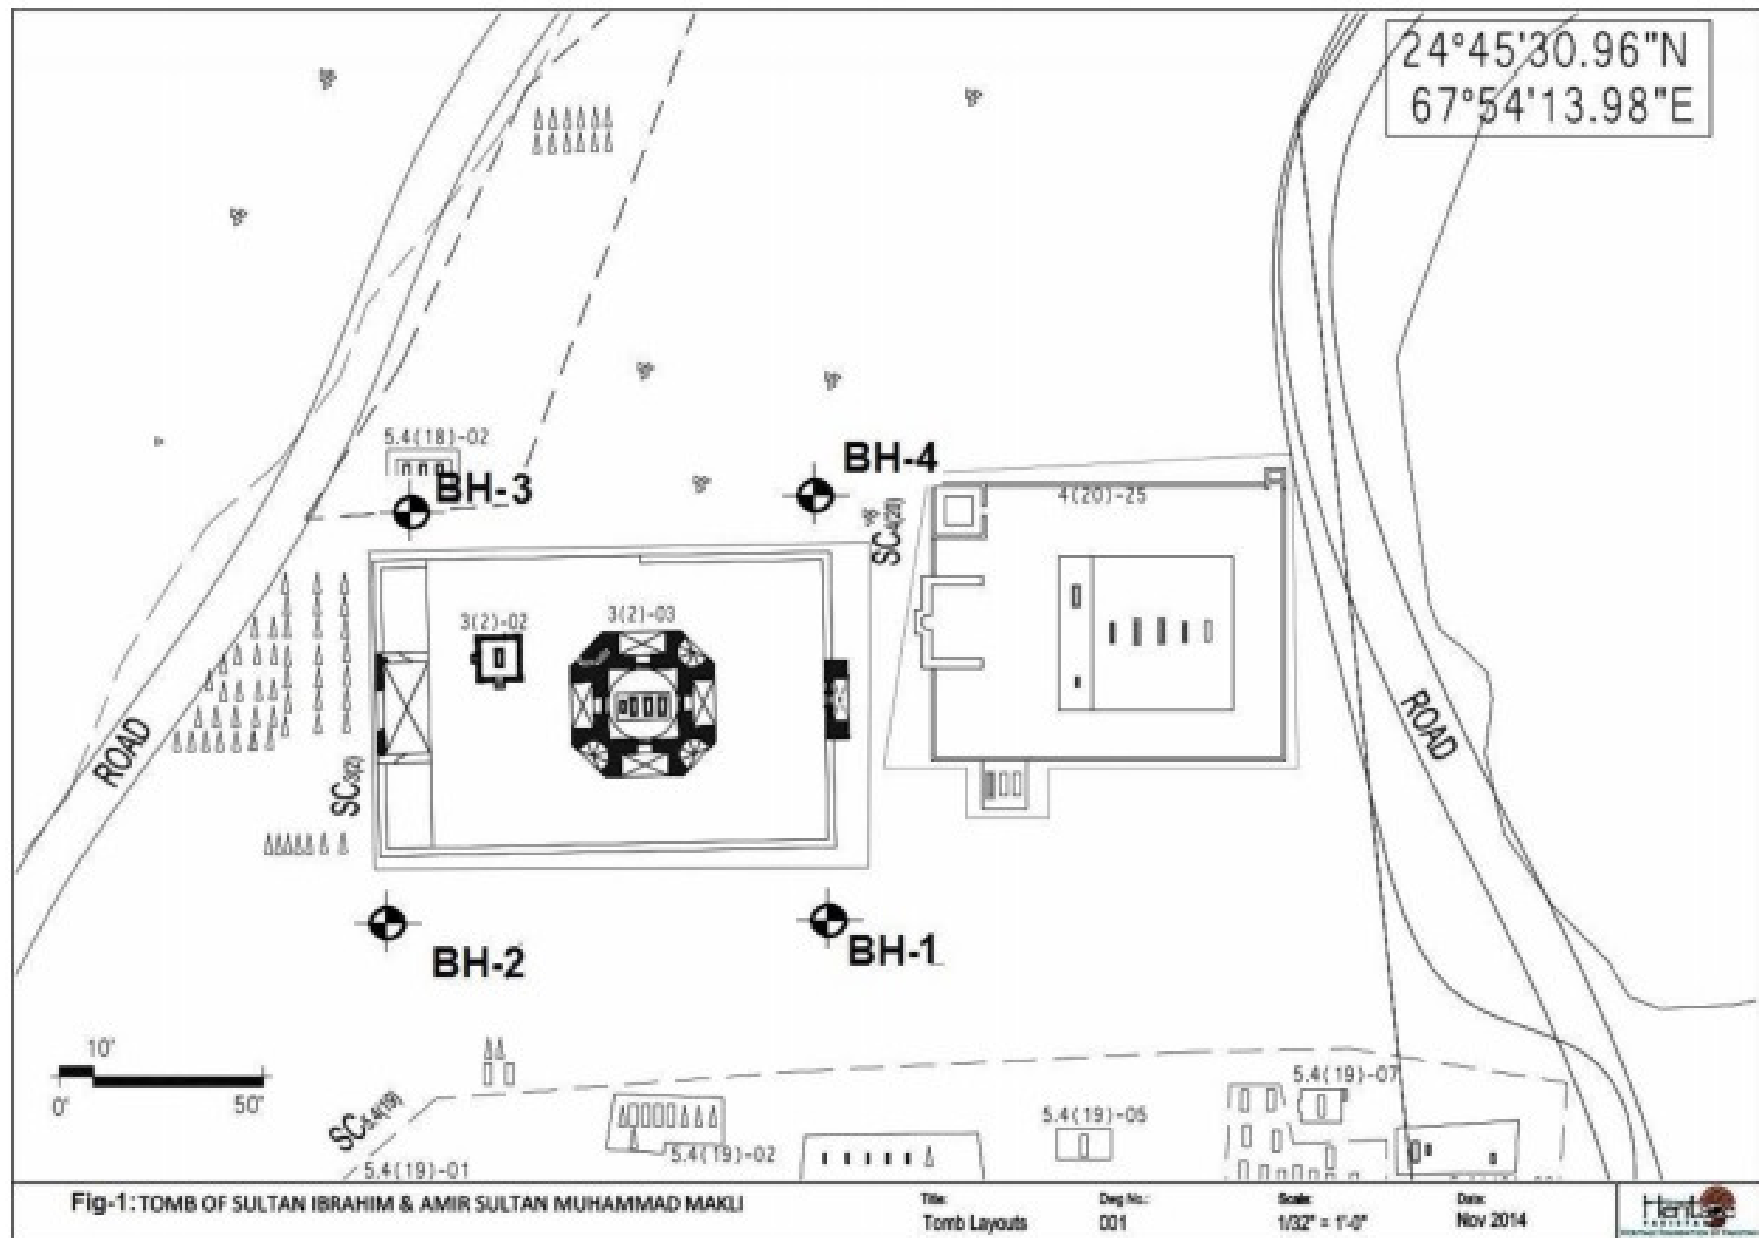
# SITE PLAN SHOWING LOCATION OF BOREHOLES

- **The program of investigation included drilling of Four boreholes up to 50ft depth, at selected locations, collection of representative subsoil samples and conducting laboratory tests with following scope:**
- **Preparation of Soil Investigation Report**
- **Recommendations**
